Conditions of Fukushima Dai-ichi Nuclear Power Station Unit 1

(As of 18:00 March 23rd, 2011)

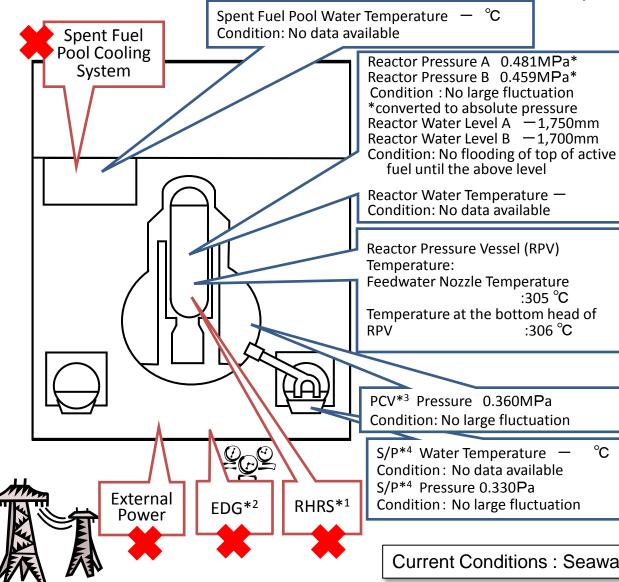
11th 14:46: Under operation, Automatic shutdown by the earthquake

11th 15:42: Report based on the Article 10 (Total loss of A/C power)

11th 16:36: Occurrence of the Article 15 event (Inability of water injection of the Emergency Core Cooling System)

12th 1:20 Occurrence of the Article 15 event (Unusual rise of the pressure in PCV)

12th 14:30 Started to vent

12th 15:36 Sound of explosion

12th 20:20 Started to inject seawater and borated water to core

23rd 02:33 The amount of injected water to the Rector Core was increased utilizing water supply line in addition to the Fire Extinguish line $(2m^3/h \to 18m^3/h)$

Current Conditions: Seawater is being injected to the core

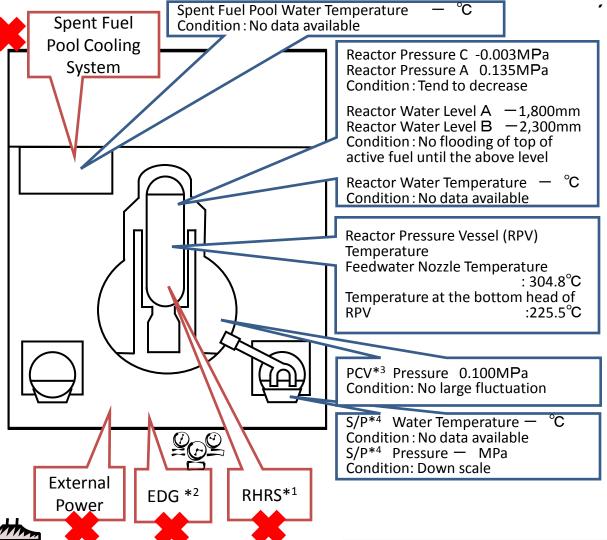
Conditions of Fukushima Dai-ichi Nuclear Power Station Unit 3

- 11th 14:46 Under operation, Automatic shutdown by the earthquake 11th 5:42 Report based on the Article 10 (Total loss of A/C power)
- 13th 5:10 Occurrence of the Article 15 event (Inability of water injection of the Emergency Core Cooling System)

- 13th 9:20 Started to vent
- 14th 7:44 Occurrence of the Article 15 event (Unusual rise of the pressure in PCV)
- 14th 11:01 Sound of explosion
- 16th around 8:30 White smoke generated.

- 17th 9:48~10:01 Water discharge by the helicopters of Self-Defense Force (4 times)
- 19:05~20:07 Water spray from the ground by High pressure water-cannon trucks (Police: once, Self-Defense Force: 5 times)

- 18th before 14:00~14:38 Water spray from the ground by 6 fire engines of Self-Defense Force ~14:45 Water spray from the ground by a fire engine of the US Military

- 19th 0:00 ∼01:00 Water spray by Tokyo Fire Department
- 19th 14:10 ~ 20th 3:40 Water spray by Tokyo Fire Department
- 20th 11:00 Pressure of PCV rose(320kPa). Afterward fell.

- 20th 20:39 ~ 21st 3:58 Water spray by Tokyo Fire Department
- 21st about 15:55 Grayish smoke generated and was confirmed to be died down at 17:55.
- 22nd 15:10 ∼15:59 Water spray by Tokyo Fire Department

- 22nd 22:43 Lightening in the Central Control Room was recovered.
- 23rd 11:03 ∼13:20 Injection of 35ton of sea water to the Spent Fuel Pool via the Cooling and Purification Line

- 23rd around 16:20 Black smoke generated.

Current Conditions: Water spray to Spent Fuel Pool and sea water injection to the Reactor Core
