Conditions of Fukushima Dai-ichi Nuclear Power Station Unit 1 (As of 06:00 March 29th, 2011)

Conditions of Fukushima Dai-ichi Nuclear Power Station Unit 2 (As of 06:00 March 29th, 2011)

Conditions of Fukushima Dai-ichi Nuclear Power Station Unit 3 (As of 06:00 March 29th, 2011)

Conditions of Fukushima Dai-ichi Nuclear Power Station Unit 4 (As of 06:00 March 29th, 2011)

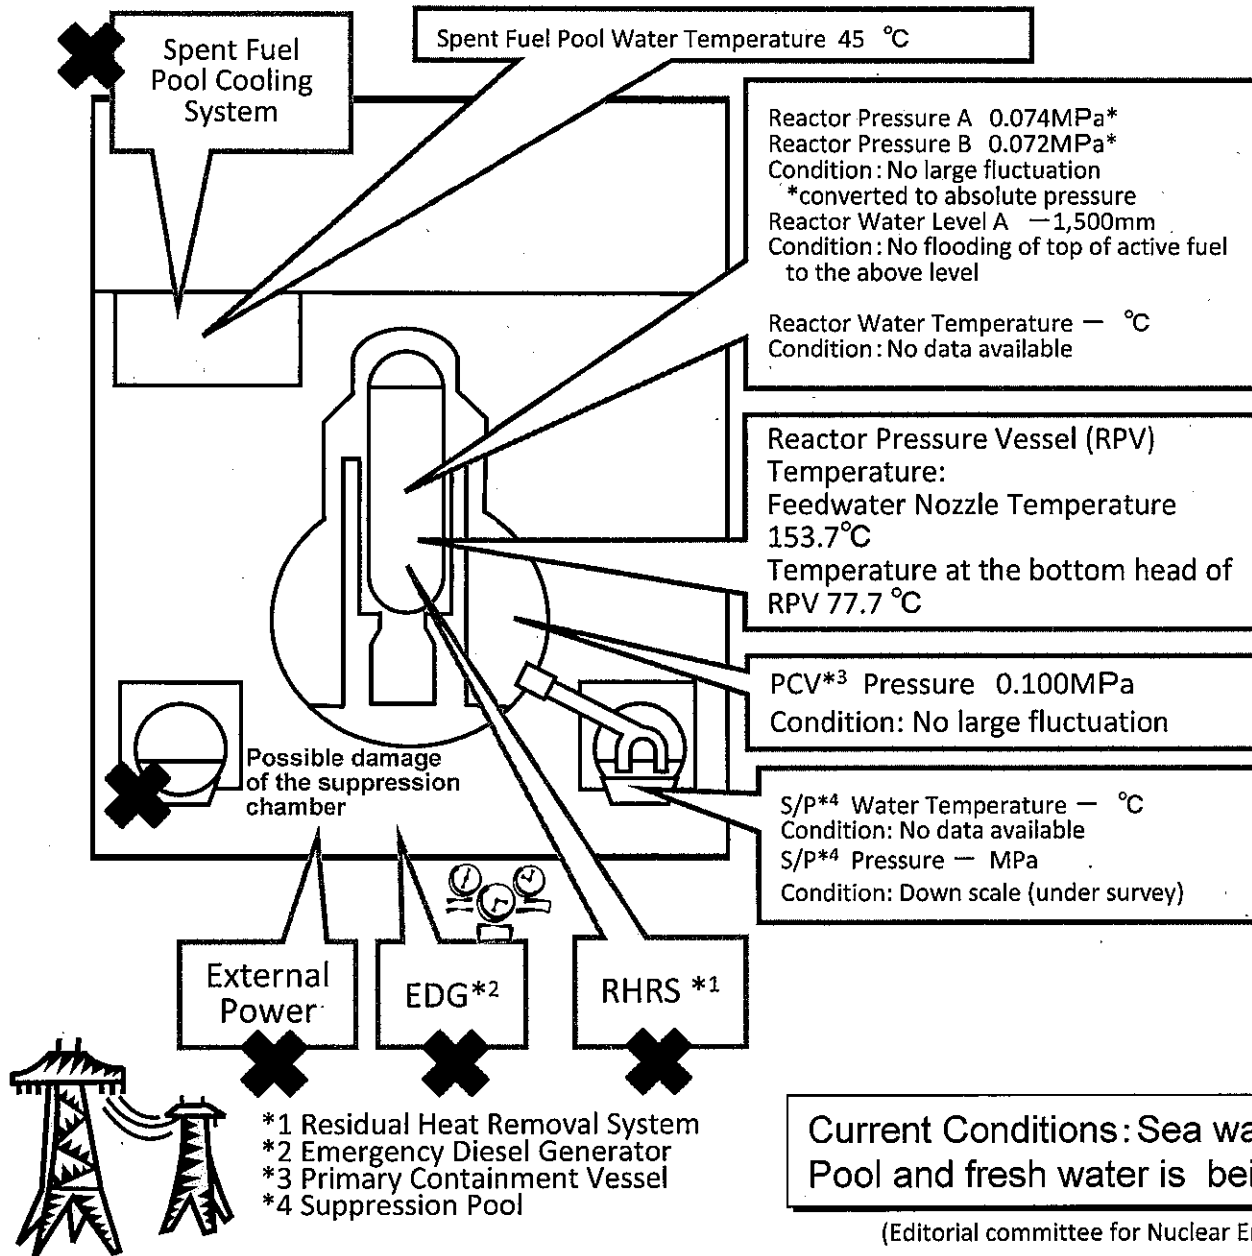
- 11th 14:46 Under operation, Automatic shutdown by the earthquake
- 11th 15:42 Report based on the Article 10 (Total loss of A/C power)
- 11th 16:36 Occurrence of the Article 15 event (Inability of water injection of the Emergency Core Cooling System)

- 13th 11:00 Started to vent
- 14th 13:25 Occurrence of the Article 15 event (Loss of reactor cooling functions)
- 14th 16:34 Started to inject water to the Reactor Core

- 14th 22:50 Occurrence of the Article 15 event (Unusual rise of the pressure in PCV)
- 15th 00:02 Started to vent
- 15th 06:10 Sound of explosion
- 15th around 06:20 Possible damage of the suppression chamber

- 20th 15:05~17:20 Approximately 40 ton seawater injection to the Spent Fuel Pool (SFP) via the Fuel Pool Cooling Line (FPC)
- 20th 15:46 Power Center received electricity.

- 21st 18:22 White smoke generated. The smoke died down and almost invisible at 07:11 March 22nd.
- 22nd 16:07 Injection of around 18 tons of seawater to SFP

- 25th 10:30~12:19 Sea water injection to SFP via FPC
- 26th 10:10 Started to inject fresh water to the Reactor Core
- 26th 16:46 Lighting in the Central Control Room was recovered.

- 27th 18:31 Switched to the water injection to the core using a temporary motor-driven pump.

Current Conditions: Sea water is being injected to the Spent Fuel Pool and fresh water is being injected to the core

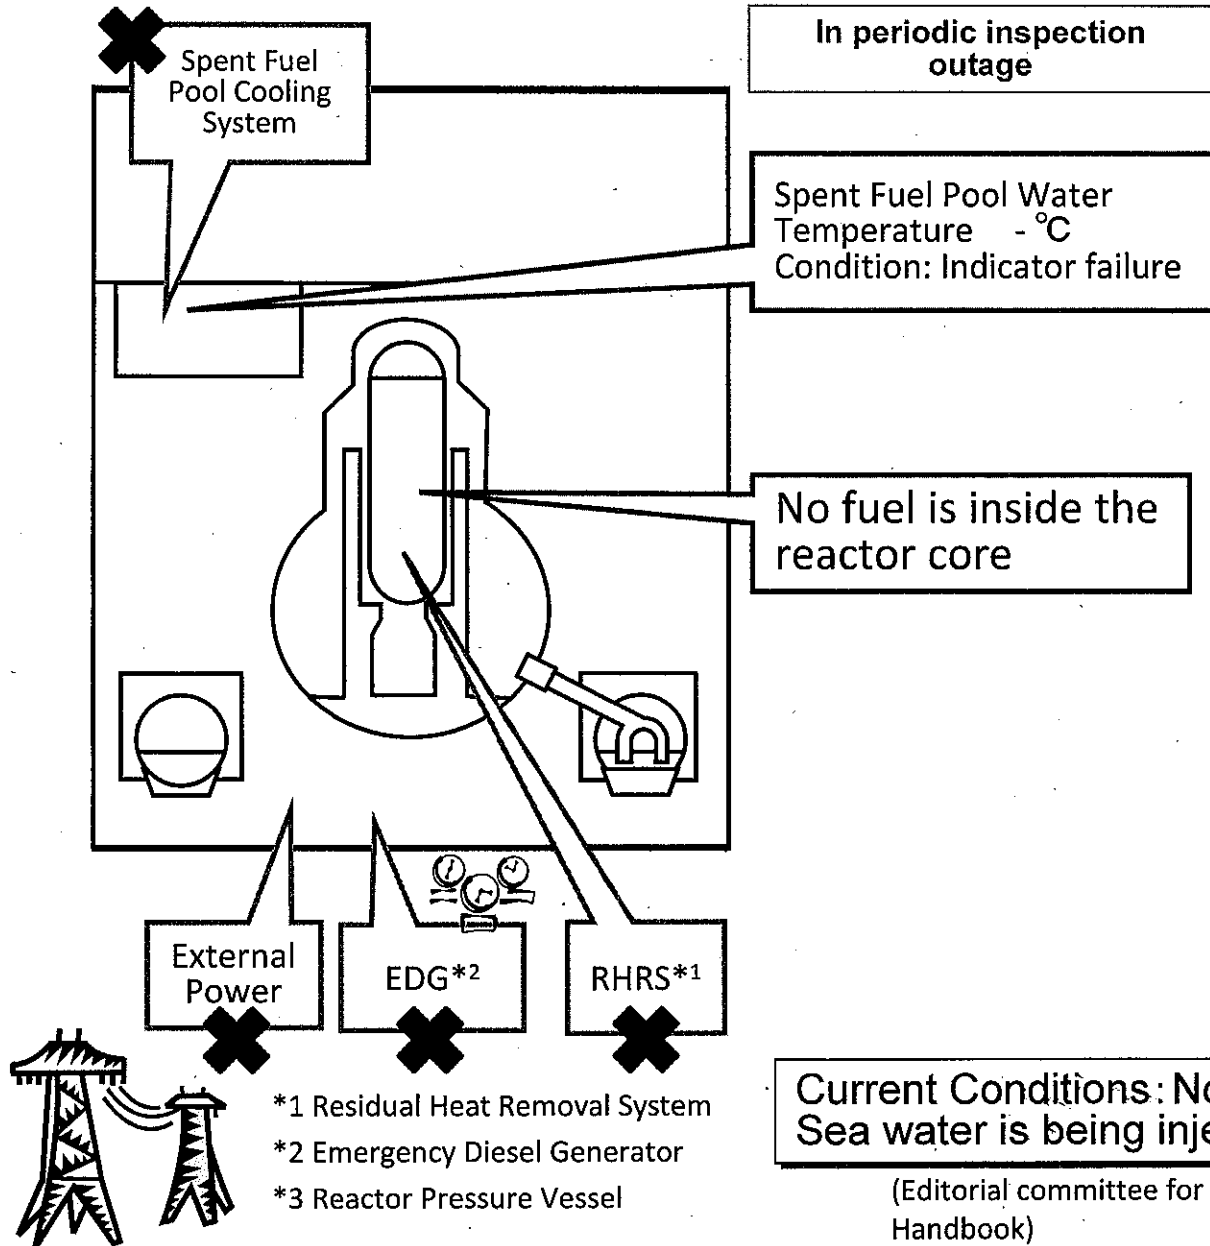
In periodic inspection outage when the earthquake occurred.

14th 04:08 Water temperature in the Spent Fuel Pool (SFP), 84°C

15th 06:14 Partial damage of wall in the 4th floor confirmed

15th 09:38 Fire occurred in the 3rd floor. (12:25 extinguished)

16th 05:45 Fire occurred. TEPCO couldn't confirm any fire on the ground. (06:15)

20th 08:21 ~ 09:40 Water spray over SFP by Self-Defense Force

20th around 18:30 ~ 19:46 Water spray over SFP by Self-Defense Force

21st 06:37 ~ 08:41 Water spray over SFP by Self-Defense Force

21st about 15:00 Work for laying cable to Power Center was completed.

22nd 10:35 Power Center received electricity

22nd 17:17 ~ 20:32 Water spray by Concrete Pump Truck

23rd 10:00 ~ 13:02 Water spray by Concrete Pump Truck

24th 14:36 ~ 17:30 Water spray by Concrete Pump Truck

25th 06:05 ~ 10:20 Sea water injection to SFP via the Fuel Pool Cooling Line (FPC)

25th 19:05 ~ 22:07 Water spray by Concrete Pump Truck

27th 16:55 ~ 19:25 Water spray by Concrete Pump Truck

**Current Conditions: No fuel is in RPV*3.
Sea water is being injected to the Spent Fuel Pool.**

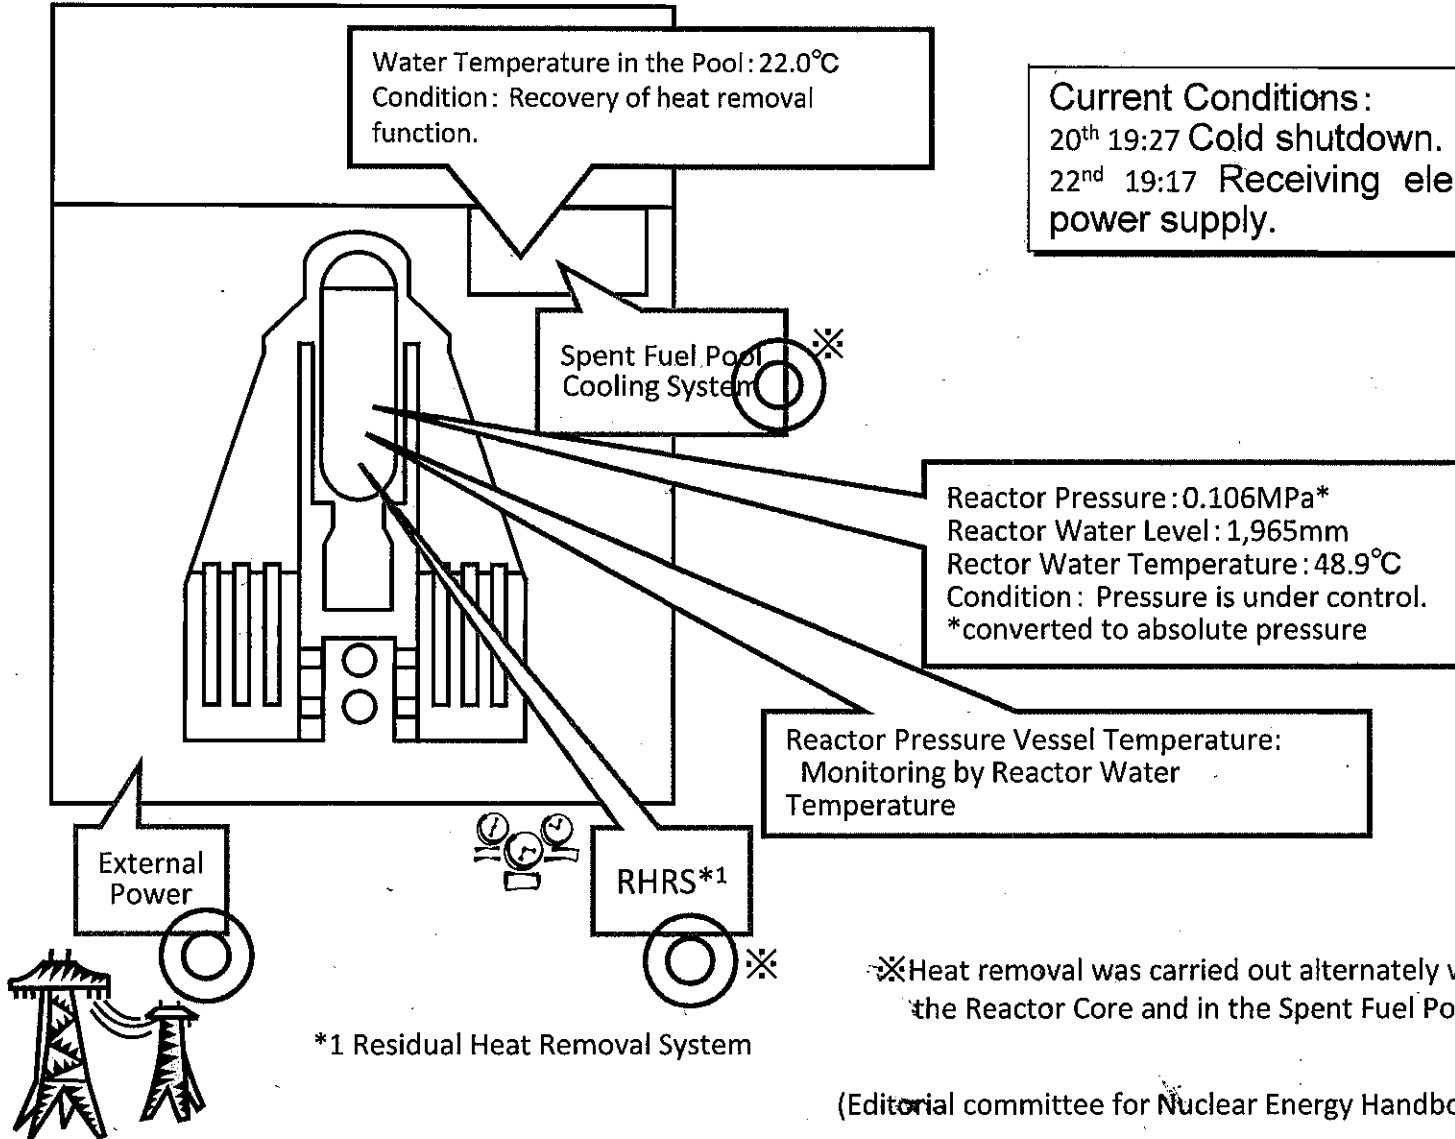
In periodic inspection outage

Water Temperature in the Pool: 22.0°C
Condition: Recovery of heat removal function.

Current Conditions:
20th 19:27 Cold shutdown.
22nd 19:17 Receiving electricity from external power supply.

Reactor Pressure: 0.106MPa*
Reactor Water Level: 1,965mm
Reactor Water Temperature: 48.9°C
Condition: Pressure is under control.
*converted to absolute pressure

Reactor Pressure Vessel Temperature:
Monitoring by Reactor Water Temperature

※Heat removal was carried out alternately with the water in the Reactor Core and in the Spent Fuel Pool.
