Conditions of Fukushima Dai-ichi Nuclear Power Station **Unit 1** (As of 11:00 March 26th, 2011)

Conditions of Fukushima Dai-ichi Nuclear Power Station **Unit 2** (As of 11:00 March 26th, 2011)

Conditions of Fukushima Dai-ichi Nuclear Power Station Unit 3

Conditions of Fukushima Dai-ichi Nuclear Power Station **Unit 4**

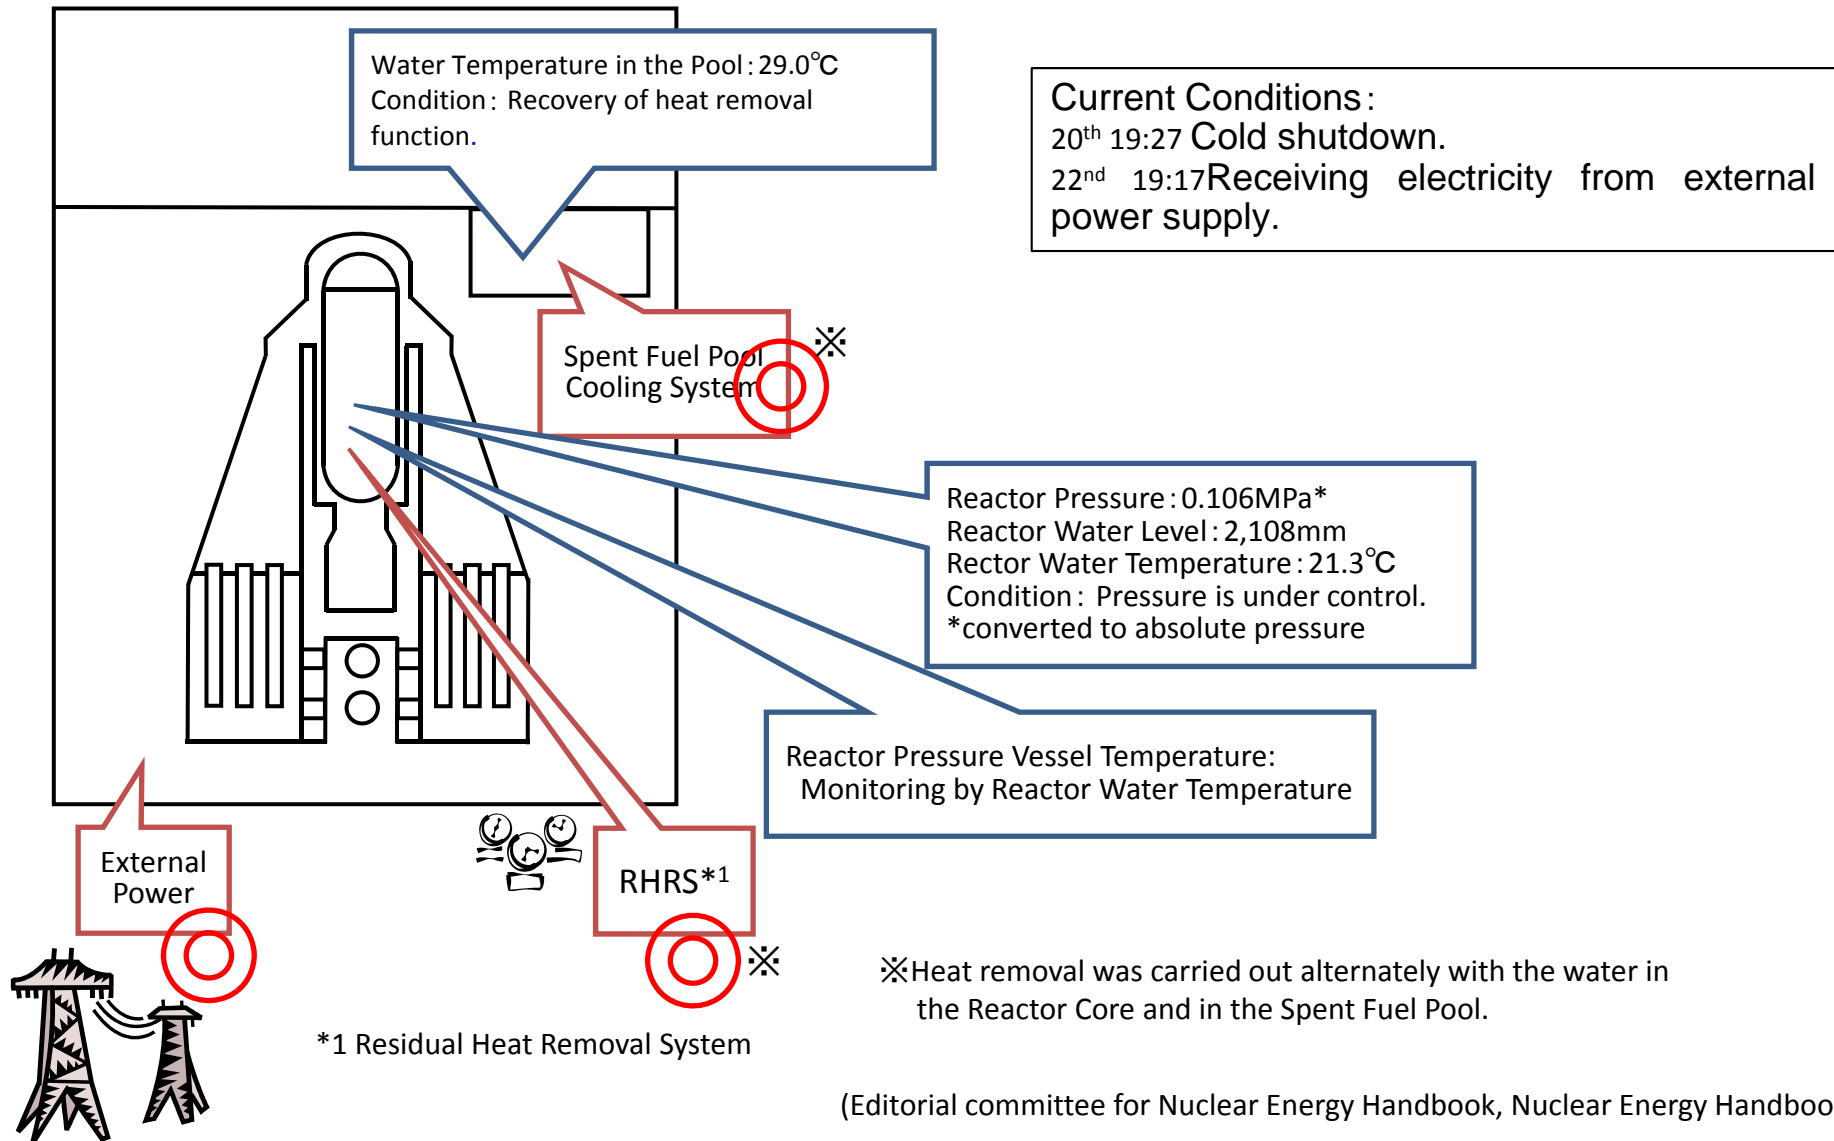
Conditions of Fukushima Dai-ichi Nuclear Power Station **Unit 6**

In periodic inspection outage
